# GRUSON'S

# CHILLED CAST-IRON ARMOUR.

JULIUS VON SCHÜTZ,

*Engineer of Grusonwerk.*

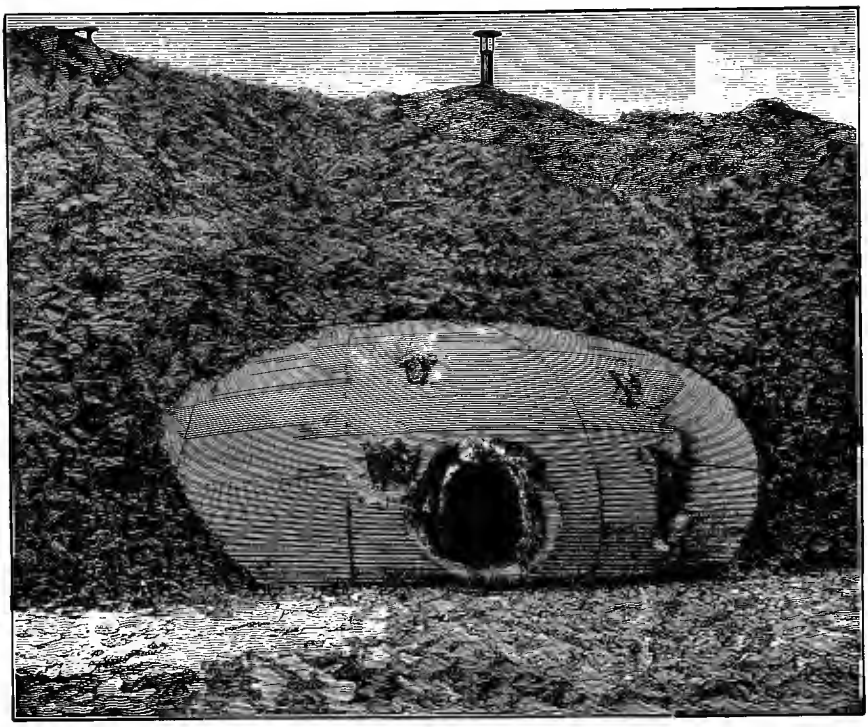
for a 72 pounder (8.3 in.) gun after the 15th round, 11/3/69.

Fig. 9 shows the armour at the end of the firing with the 9.4 in. gun.

The cracks formed were so fine that they do not appear visible in the photograph.

To save ammunition, the firing was then continued with the long 8.3 in. hooped gun at a distance of 166 yards. It should be noted that 8 shots, rounds 12 and 16 to 22, struck on about the same place, close to the port. The experiment was intended merely as a test of the material, without the conditions of actual warfare, but was, nevertheless, a very severe trial on account of the small thickness of the plates.

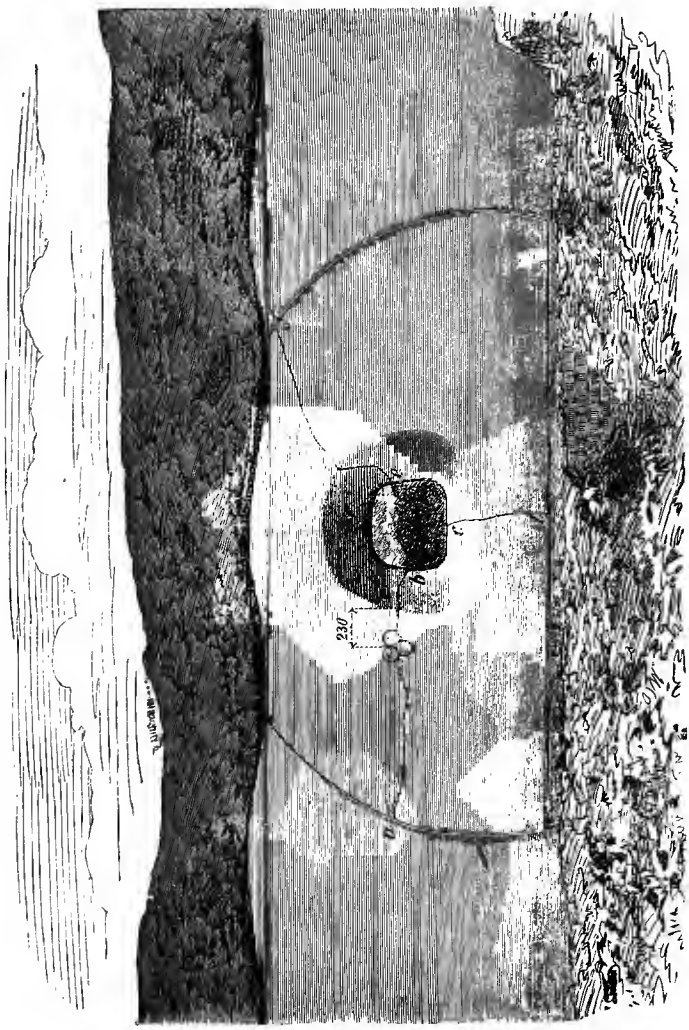
Fig 13.
*The first Port Plate of the Chilled Iron Armour Battery for* 8.3 in. *(21 cm) guns, after the third shot,* 5/12/73.

The effect of the first shot was a small and hardly perceptible indent and a short hair crack, and exhibited in a surprising manner the extraordinary reacting power of the material.

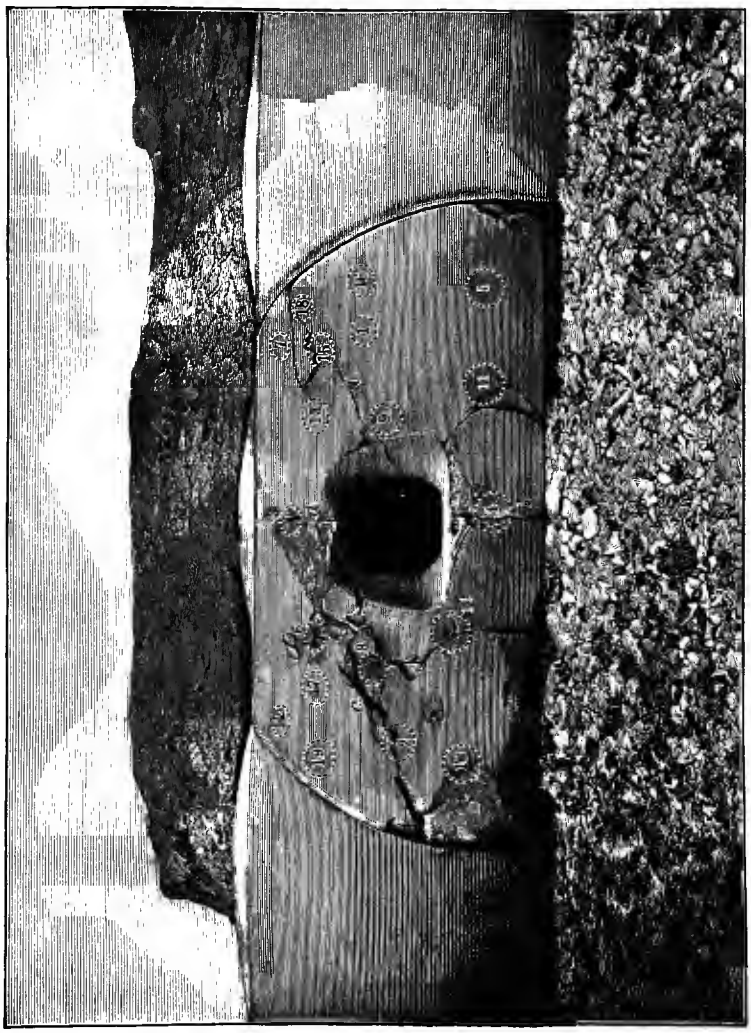
Fig. 14.
*The Second Port Plate of the Chilled Iron Armour Battery for 8.3 in. (21 cm) Guns, after the 19th Shot. 21/8. 74.*

The fourth hit produced crack *b*, under *a*, splitting the plate into two halves, also crack *c*.

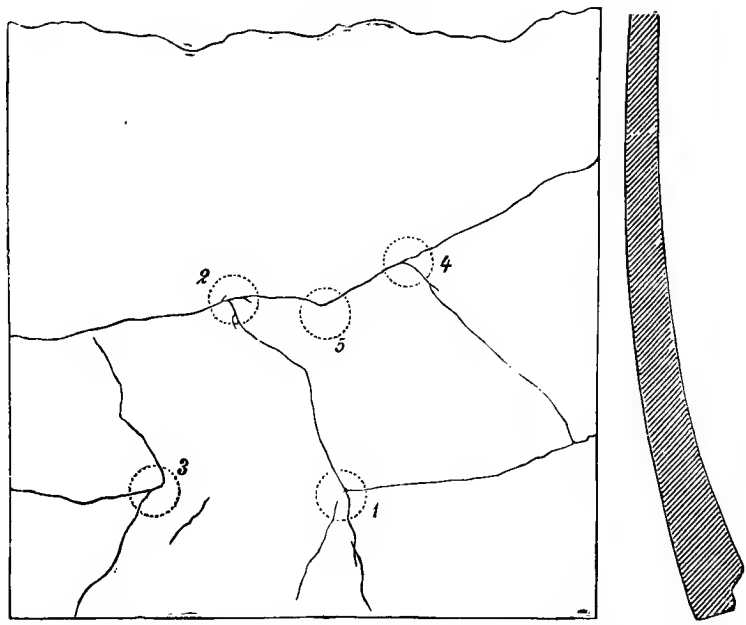
*Profile and Position of Hits of the Trial Roof Plate of the Chilled Iron Armour Battery for* 8.3 in. *(21 cm) Guns.* 21/8/74.

Five hits in all were made; of these the two first only starred the surface, the third cracked the plate as shown, the fourth cracked the plate into two parts, the fifth made no new crack but extended the previous ones to the under surface, and from crack 4 broke off a piece weighing about 2.2 lb. which fell through.

**Summary:** The Committee declared the plate to have displayed **most satisfactory powers of resistance**, and moreover, considering the small target exhibited by the roof-plate ($\frac{1}{6}$ of the port plate), it was improbable that a ship would be able to place so many hits upon it.

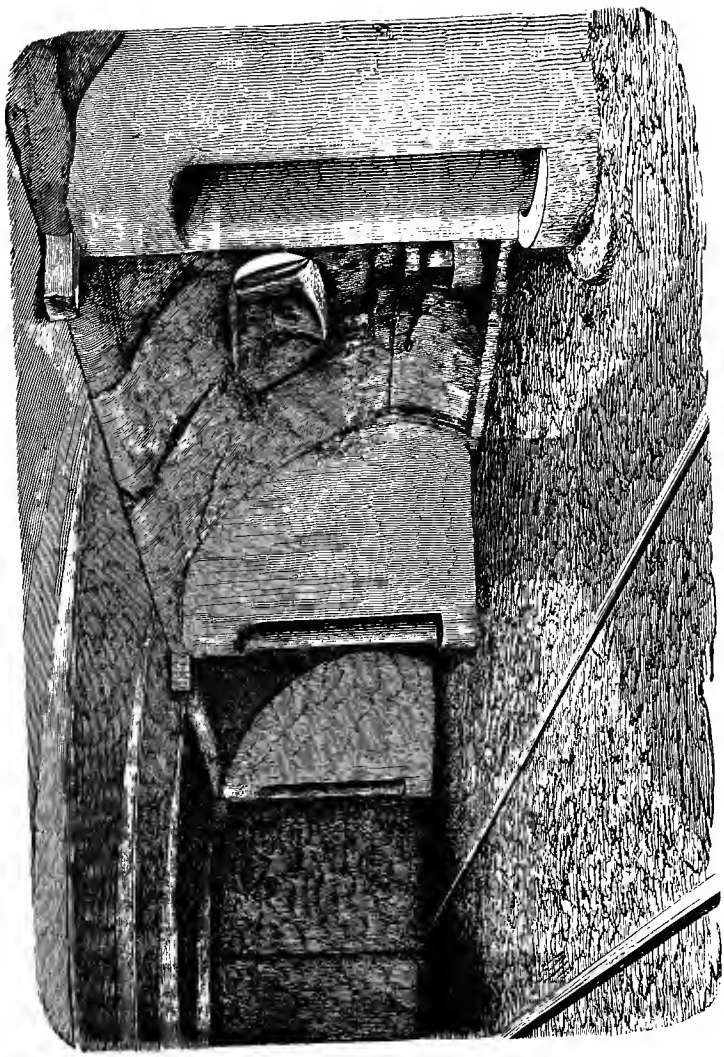
Fig. 16.
*Interior of a Chilled Iron Armour Battery for* 8.3 in. *(21 cm) Guns, at the conclusion of the firing.* 21/8/74.

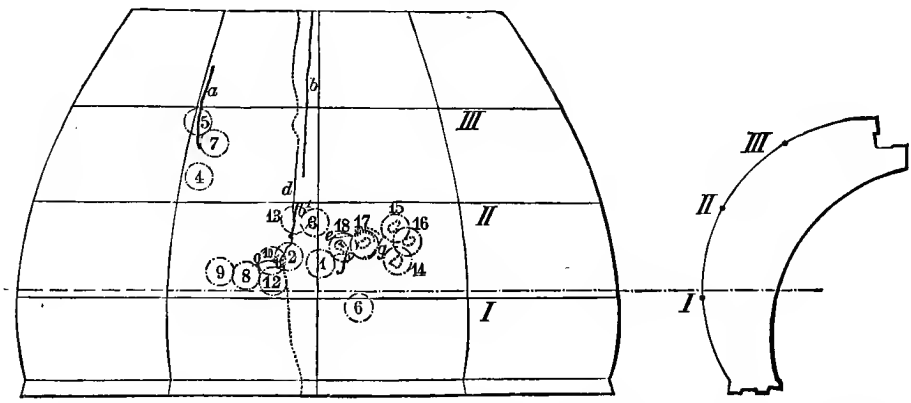
*Profile and Position of hits of the Trial Side-Plate of the Chilled Iron Armour Turret for two 4.7 in. (12 cm) Guns.* 23/12/82, 10/1 *and* 27/4/83.

Effect: The same as in rounds 1 and 2, an indent 00.8 in. deep, marked

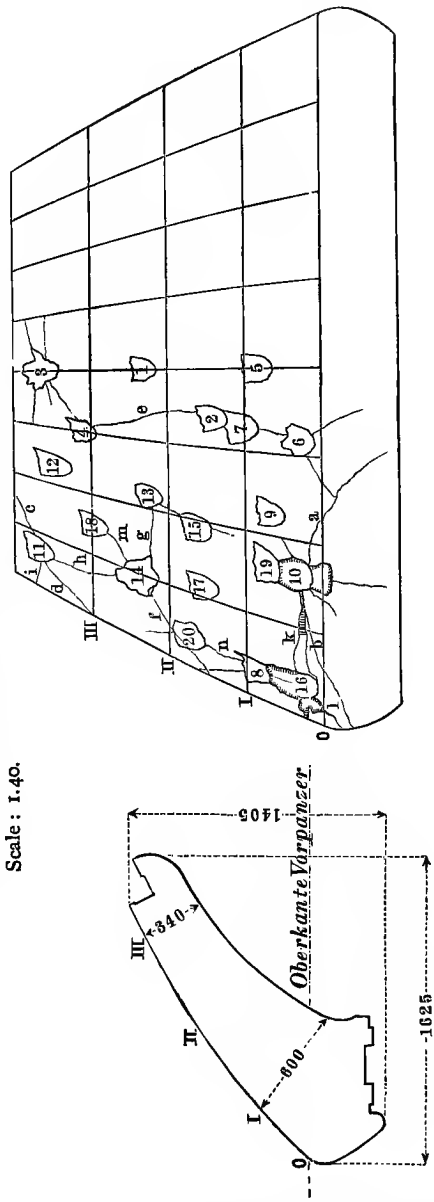
Fig. 25.
*Profile and Diagram of Hits of the Trial Side Plate of a Chilled Armour Turret for two 4.7 in. (12 cm) Guns 19 and 20/1/85.*
Scale: 1.40.

Point struck: 55 in. left of centre line, 37.4 in. above glacis plate edge.

Angle of impact: 34° 15′
Effect: Indent 4 in. broad, and 0.3 in. deep.
No cracks.

Shot glanced upwards and split into many small pieces, which showed, as did also the subsequent rounds, a great degree of hardness.

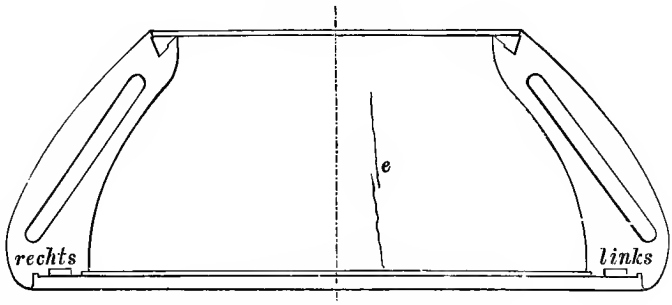
*Back of Trial Side Plate of a Chilled Armour Turret for two* 4.7 *in.* (*12 cm*) *Guns, after the twentieth round,* 20/1/85.

Effect : Indent 4.7 in. broad, and 0.2 in. deep
Two radial hair cracks.
At the back of the plate, crack *e* as a hair crack visible for 28 in., beginning about 21.3 in. from the upper edge, and running vertically downwards about 8.7 in. from the centre line.
Shot deflected and broke up.

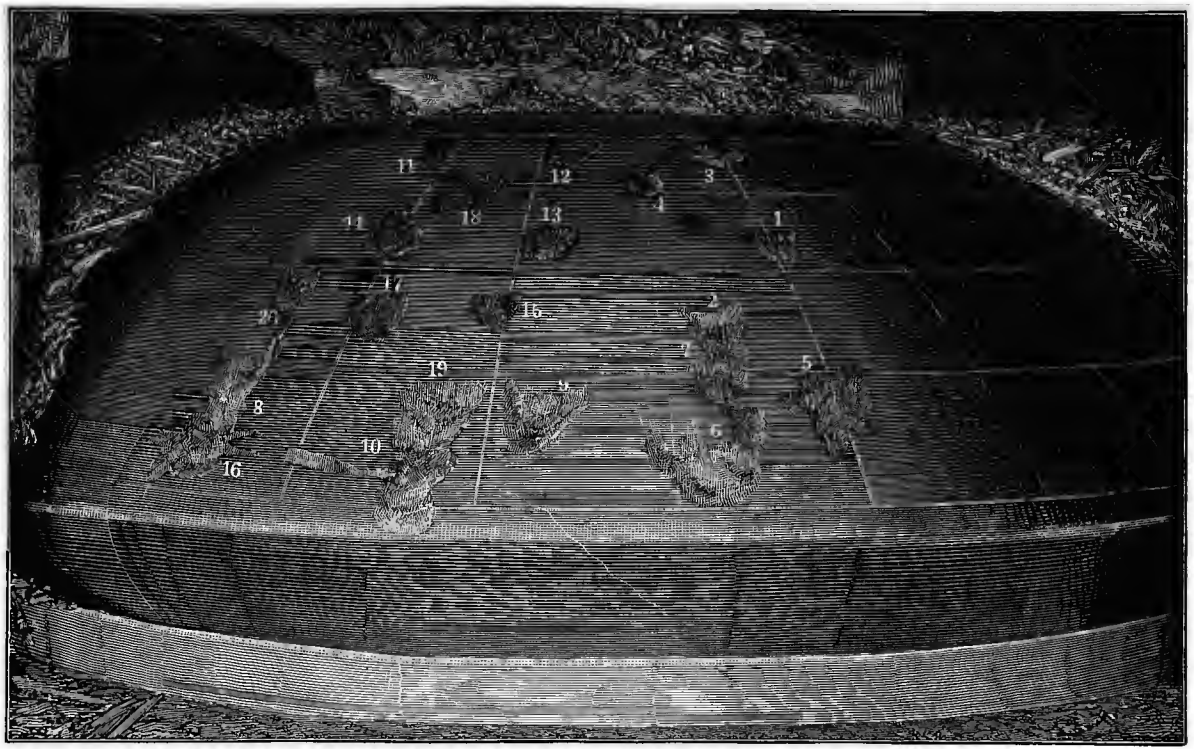
*Side Plate of Chilled Iron Armour Turret for two 4.7 in. (12 cm) guns after Round 20.* 20/1/85.

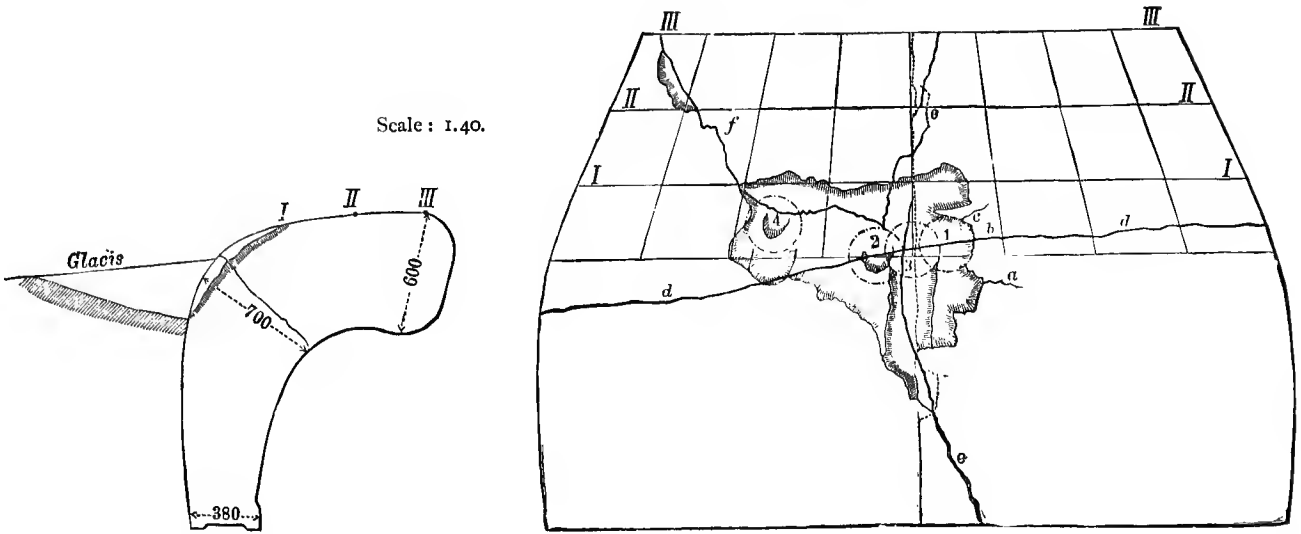
*Profile and Diagram of hits of the trial glacis Plate of the Chilled Iron Armour Turret for two* 12 *in.* (30.5 *cm*) *guns.* 13/8/83.

On inspection of the glacis, it was seen that crack *e*, instead of following, as was supposed, the chill crack, crossed and formed a branch towards the bottom edge of the plate (*see* Fig. 28).

In the upper part of the armour plate the crack *e* followed twice for a short distance the chill crack; but it is to be noted that the plane of fracture was a constant curve, and only joined superficially the irregular zigzag of the chill crack From this it was clear that the crack *e* was in the interior of the plate entirely independent of the chill crack, as might be expected from the small depth of the chill crack (2.8 in.) in proportion to the thickness of the plate (27.6 in.)

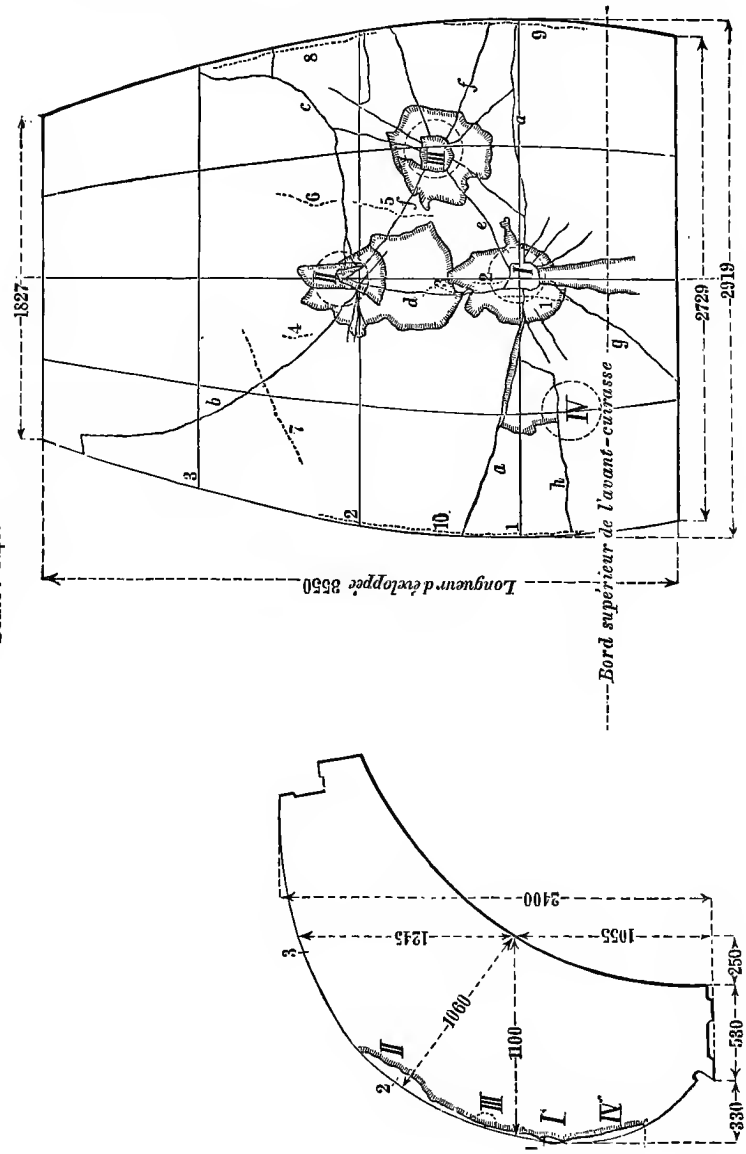
A horizontal crack *a* reached both edges of the plate, on

Fig. 30.
*Profile and Diagram of hits of the Trial Side Plate of the Chilled Iron Armour Turret for two 12 in. (30.5 cm) Guns.* 22|10|83.
Scale: 1.40.

the left 49.2 in., on the right 35.8 in. Above the lower edge of the plate, along the crack, to the left of point struck, an abrasion 1.2 in. broad, and 11.8 in. by 15.7 in. long.

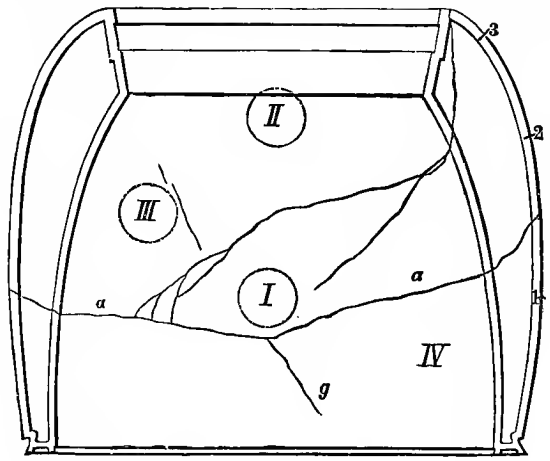
*Back of the Trial Side Plate of the Chilled Iron Armour Turret for two 12 in. (30.5 cm) Guns after the third round, 22/10/83.*

Back of the plate: The cracks at back were much widened by the falling of the parts of the plates in front; but no new cracks were observed, as the effect of the round had been concentrated on the

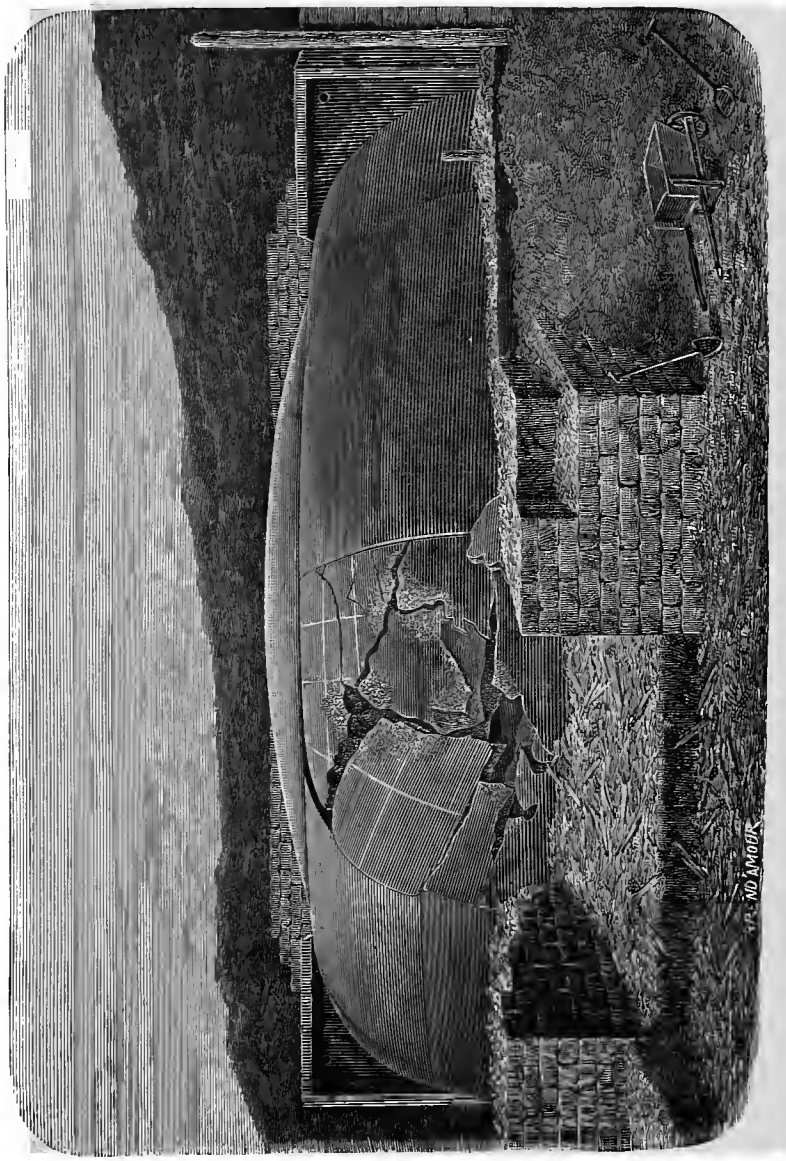
Fig. 33.
*Side Plate of the Chilled Iron Armour Turret for two* 12 *in.* (30.5 *cm*) *Guns after the fourth round,* 22/10/83.

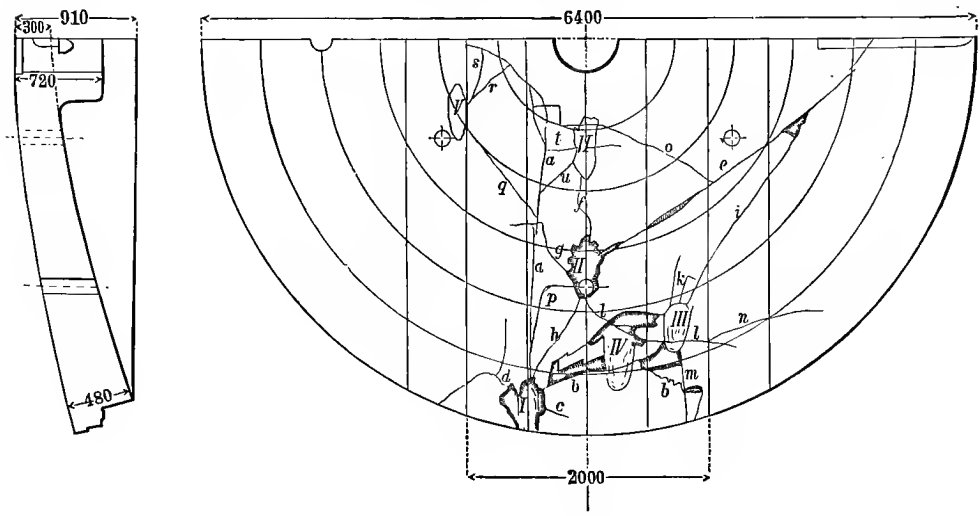
*Profile and Diagram of Hits of the Trial Roof-plate of a Chilled Iron Armour Turret for two 12 in. (30.5 cm) Guns.* 26 *and* 28/5/84.

Angle of impact : 24° 14′.

Effect : Chiselling out of surface 0.9 in. deep, with abrasions of 23 by 11.4 in. greatest extension.

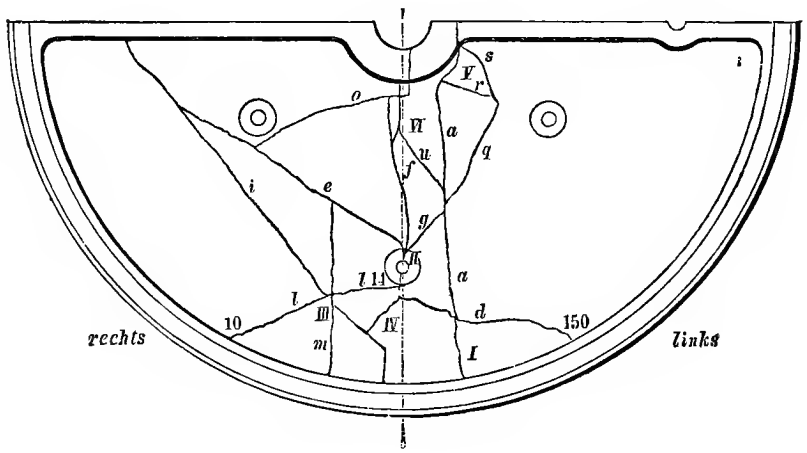
*Back of the Trial Roof Plate of the Chilled Iron Armour Turret for two 12 in. (30.5 cm) Guns after the sixth round, 28/5/84.*

New cracks *n*, *o*, *p*, *d* to the edge of the plate, *h* lengthened to hit 1. The piece of plate bounded by crack *b* was thrust up about 1.4 in.

An examination of crack *b* showed that it ran in the metal close to the round edge of the plate, but was not visible at the back of the plate.

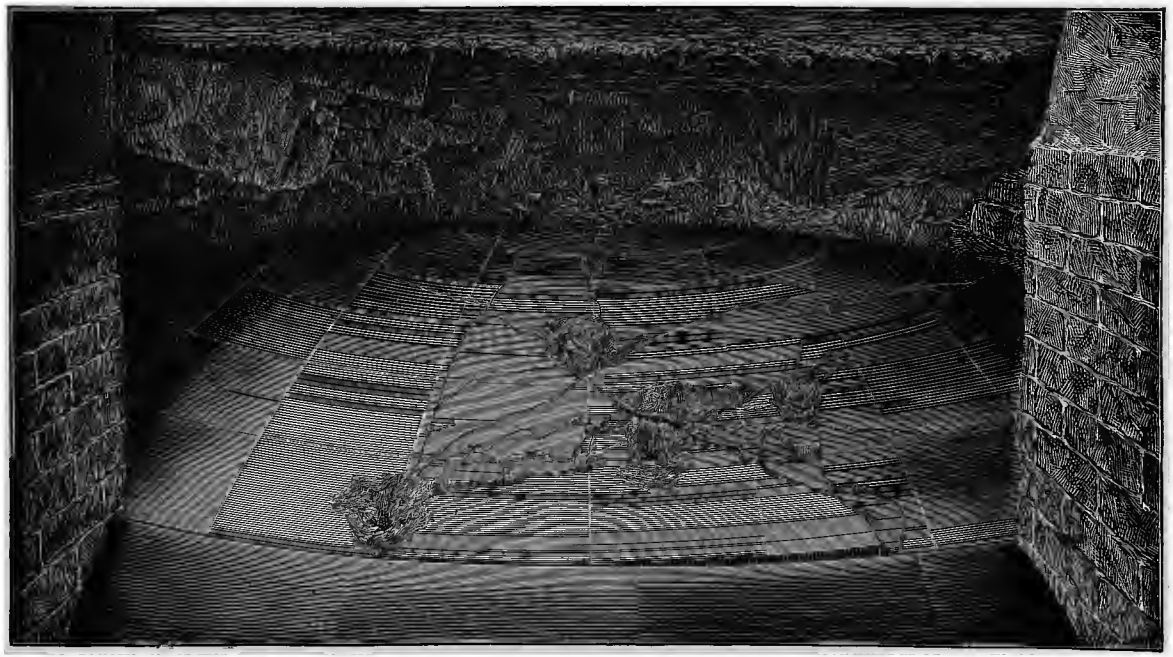
*The Roof Plate of the Chilled Iron Armour Turret for two 12 in. (30.5 cm) Guns, after the sixth round.* 28/5/84.

**Summary:** The plate had withstood six rounds with a total energy of 57,016 foot tons, that is, 1198.3 foot tons per ton of material of the armour, and thus displayed an endurance beyond the necessities of actual service, as in this case the shot could never strike at so great an angle. The dimensions selected had proved appropriate, and the advantage of the arched form had been clearly demonstrated, as, for instance, round 4 struck a piece of plate completely loosened, but was unable to drive this piece into the interior of the turret, although the resistance of the arch, owing to the cracking of the bed plate, had been considerably reduced. The 6th round, also, struck an already loosened piece without being able to dislodge it towards the interior.

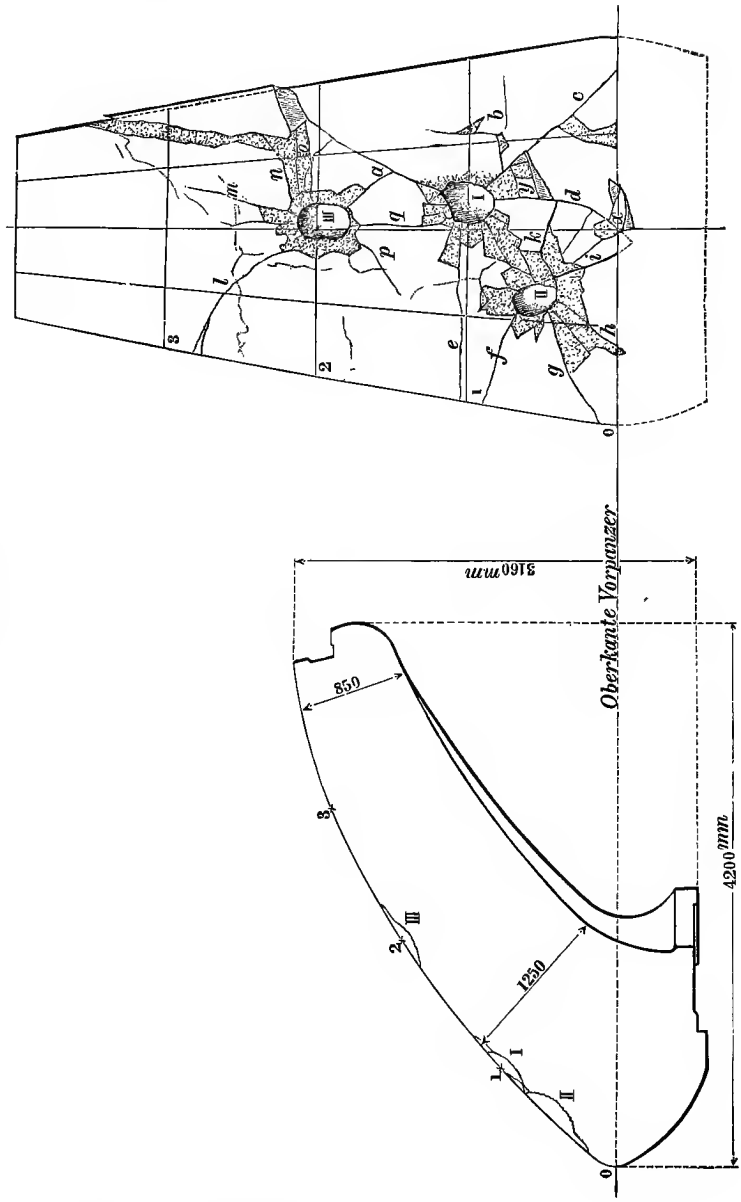
Fig. 38.
*Profile and Diagram of hits of the Trial Side Plate of the Chilled Iron Armour Turret for two 15.7 in. (40 cm) Guns. 20, 24 29/4/86.*
Scale : 1.60.

At the upper edge of the glacis a small three-cornered piece, 0.8 to 1.2 in. large, was knocked out (marked *x* in Fig. 38), as also a four-sided piece *y* under hit 1.

Effect: Excision 15.7 in. long, 11.8 in. broad, and 1.6 in. deep, with surrounding abrasions also running radially from the point struck to the edges hair-cracks *l*, *m*, *n*, *o*, *p*, and a vertical crack *q* 0.2 in. wide. In consequence of the want of lateral support the upper part of the plate was forced downwards a little, so that the under parts stood out along crack *a* about 0.4 in. and along crack *e* about 0.2 in., and, in consequence, at the right edge a large piece of plate, seen in Fig. 38, had broken away and was pushed out. The greatest thickness of this fracture was 10 in., the other dimensions are seen in the Fig.

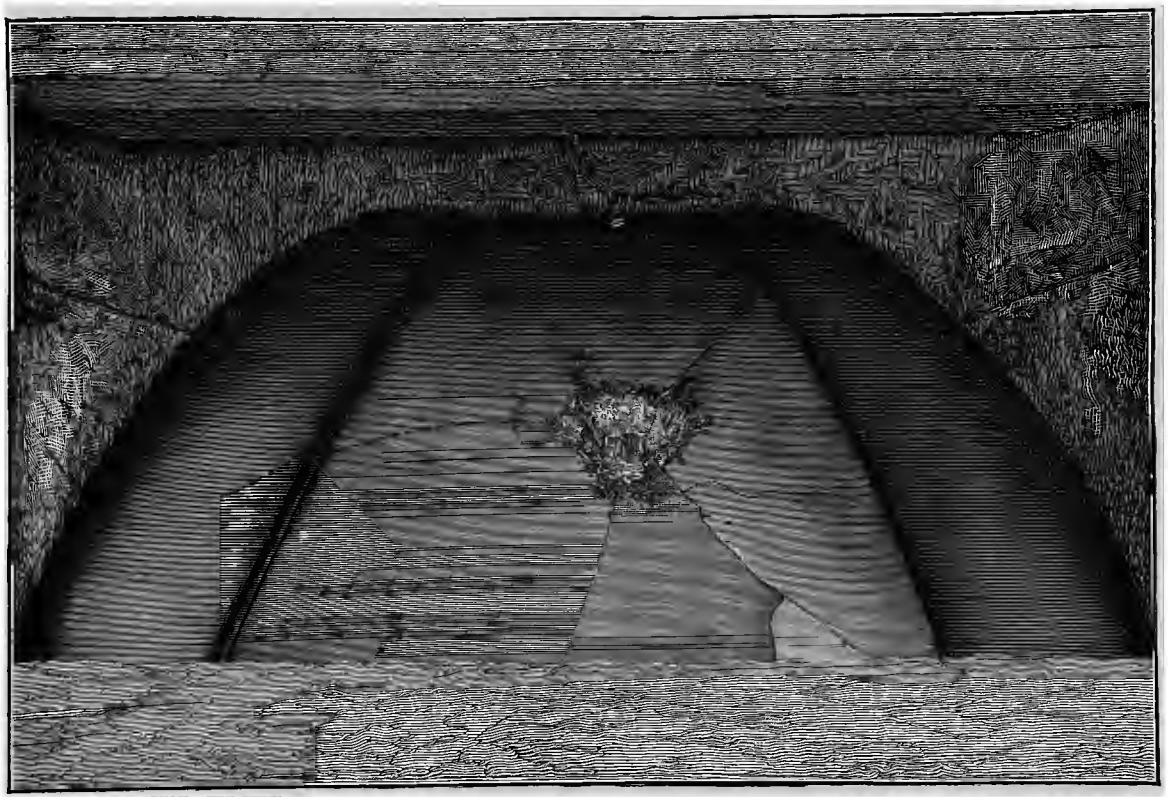
*The Side Plate of the Chilled Iron Armour Turret for two* 15.7 *in.* (40 *cm*) *Guns after the first round.* 20/4/86.

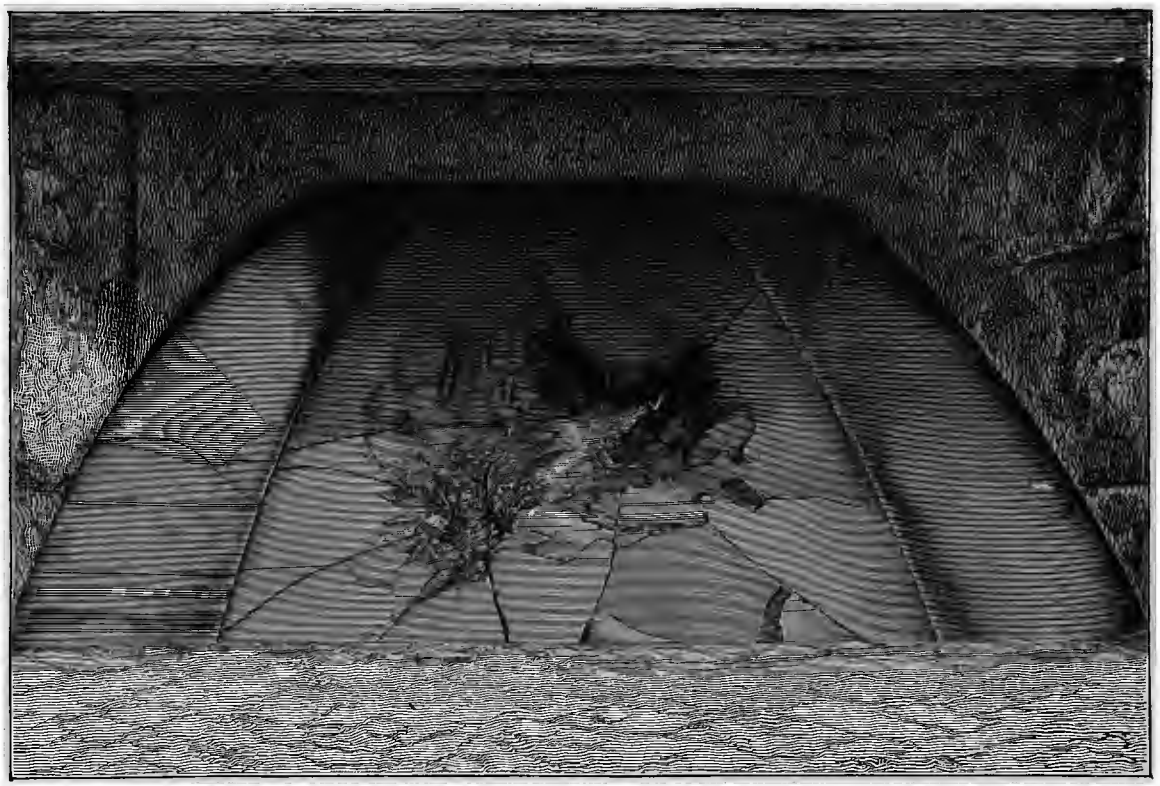
*The Side Plate of the Chilled Iron Armour Turret for two* 15.7 *in.* (40 *cm*) *Guns after the second round.* 24/4/86.

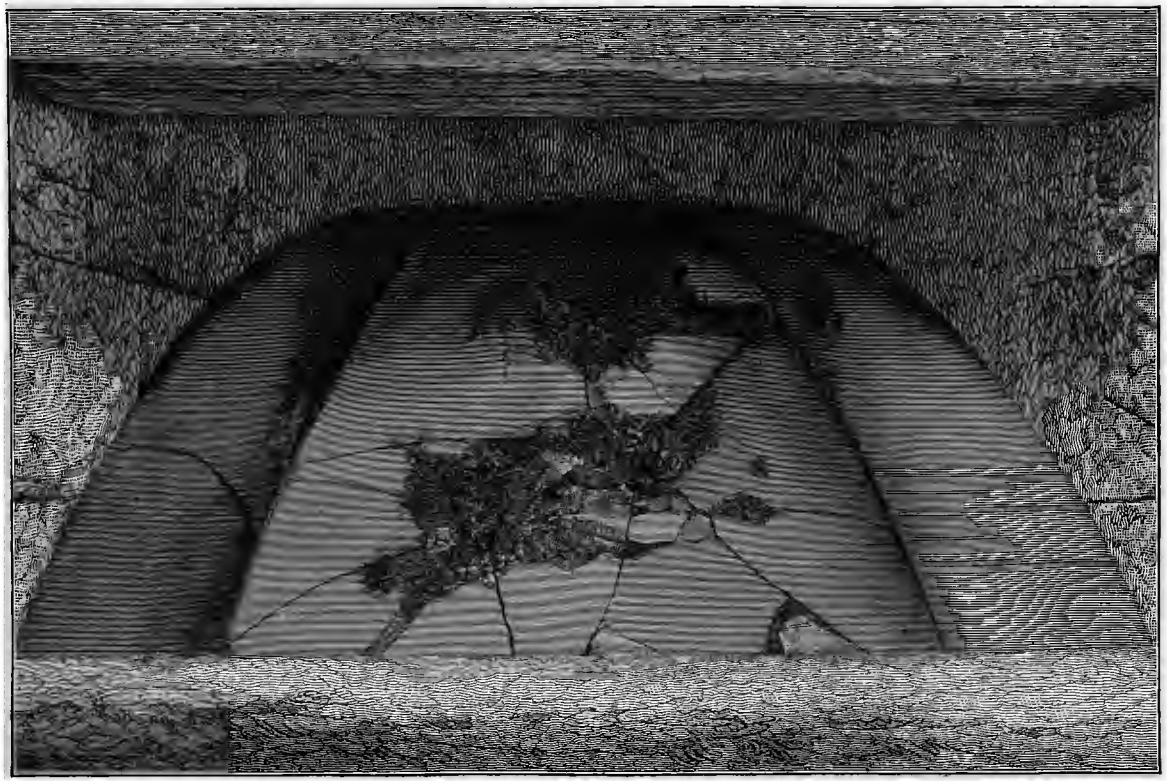
*Side-Plate of the Chilled Iron Armour Turret for two* 15.7 *in.* (40 *cm*) *Guns after the third round.* 29/4/86.

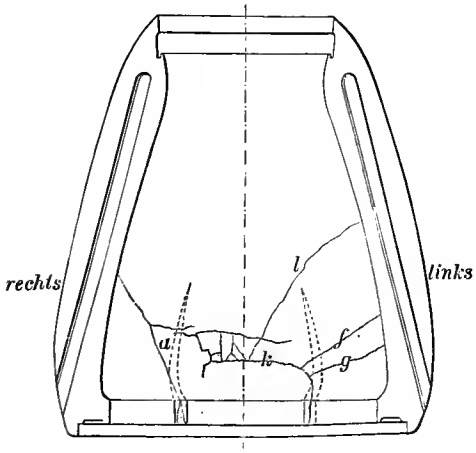
Fig. 42.
*Back of the Trial Side Plate after the third round.*
29/4/86. Scale: 1.60.

Back of the plate: A new crack running upwards and to the left from the centre line was seen apparently in connection with the hair crack *l* on the front surface; *k* was lengthened to the lower edge of the plate, and between *k* and *b* a nest of several small cracks had appeared owing to which a small wedge-shaped piece weighing about 4.4 lb., shown in dotted lines, had fallen from the inner surface. It measured 3.5 by 4.3 by 3.2 in.

Close to this there was a small surface abrasion about 0.4 in. deep.

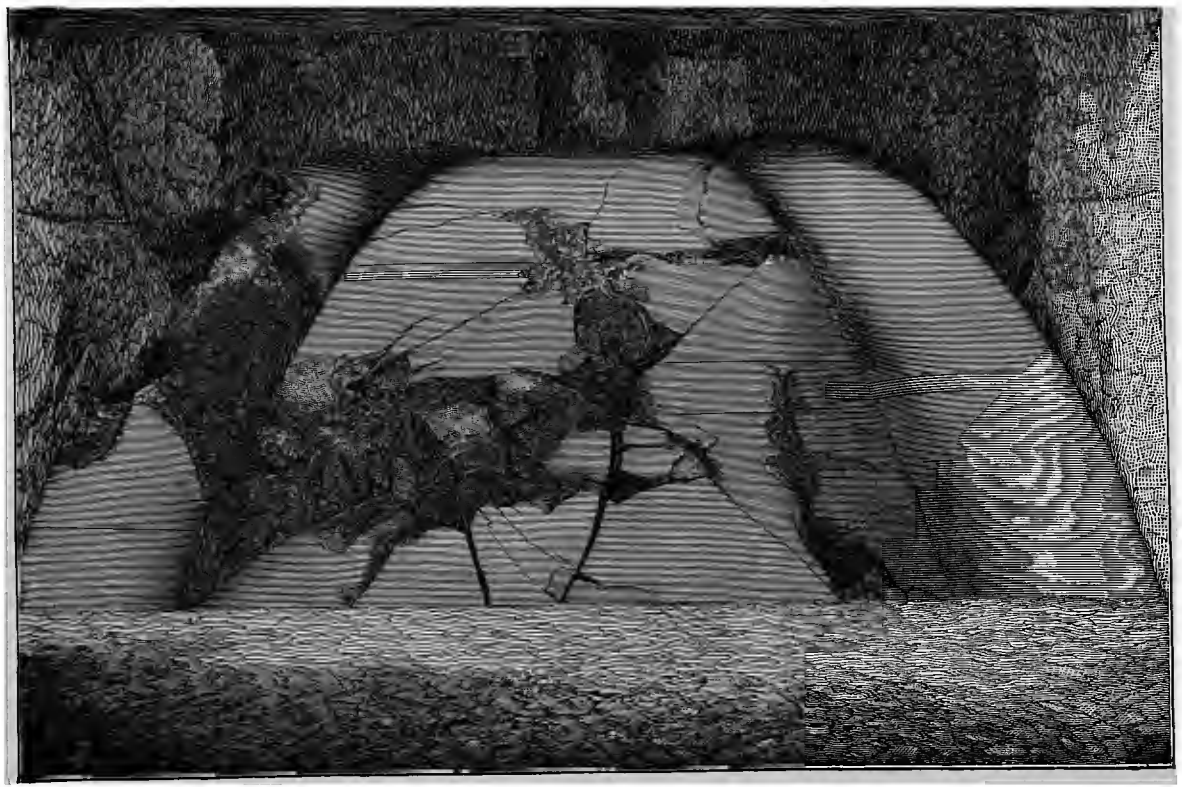
*Side Plate of the Chilled Iron Armour Turret for two* 15.7 *in.* (40 *cm*) *Guns after the sixth round.* 22/6/86.

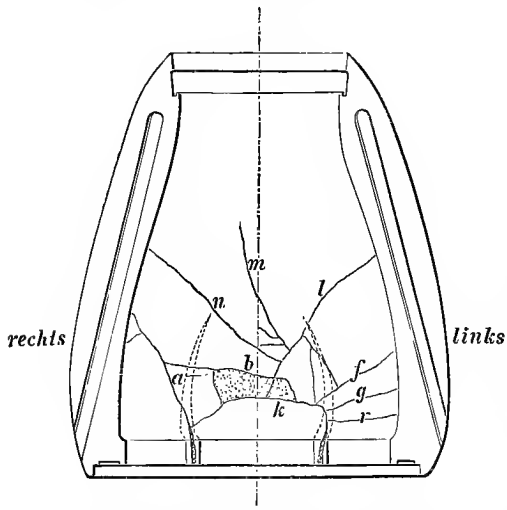
Fig. 45.
*Back of the Trial Side Plate of the Chilled Iron Armour Turret for two* 15.7 *in.* (40 *cm*) *guns after the sixth round.*
22/6/86. Scale: 1.60.

**Summary:** The first part of the trial had showed once more that steel shot of small calibre break up on striking an oblique surface of armour, in the same way as the 16.9 in. shell fired in April.
